Rediscovery and Initial Exploration of RCAF B-24 Liberator Plane Wreck in Gander Lake

Figure 4: Preliminary site map of RCAF Liberator bomber wreck site in Gander Lake. The wreck site extends beyond the area shown and has yet to be fully explored. Locations of the outlying objects are approximate. Portions of this drawing are adapted from Liberator GR Mk. V (Canada) plans contained in Vincent (1975). Map: Neil Burgess

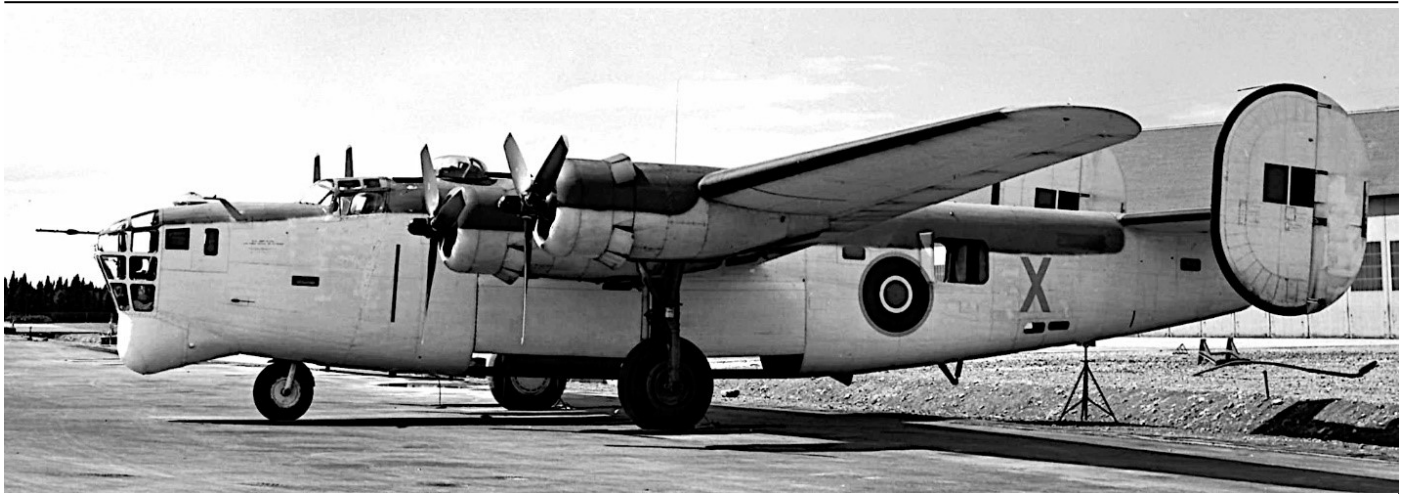
Figure 1: Consolidated Liberator bomber 595 “X” of No. 10 Bomber Reconnaissance Squadron based in Gander. This aircraft had the same design and markings as Liberator 589 “D” that crashed into Gander Lake.

Liberator 589 “D” was one of the first 15 Consolidated Liberators GR Mk. V (Canada) delivered to the RCAF in April 1943 (Figure 1) (Vincent 1975). (It was a B-24D under the American USAAF classification system.) It joined No. 10 (BR) Squadron at Gander in late April, 1943, to carry out very-long-range anti-submarine patrols and convoy escorts over

Examination of the many features of and markings on the plane wreck in the underwater videos and photos confirm that this is the wreck of a Consolidated Liberator bomber. The markings on this aircraft are consistent with those of Liberator bombers used by the RCAF and RAF for anti-submarine patrols. The features and markings of this bomber wreck match those of Liberator GR Mk. V (Canada) bombers that belonged to No. 10 (BR) Squadron of the RCAF in 1943 (see Figure 1). The wreck cannot

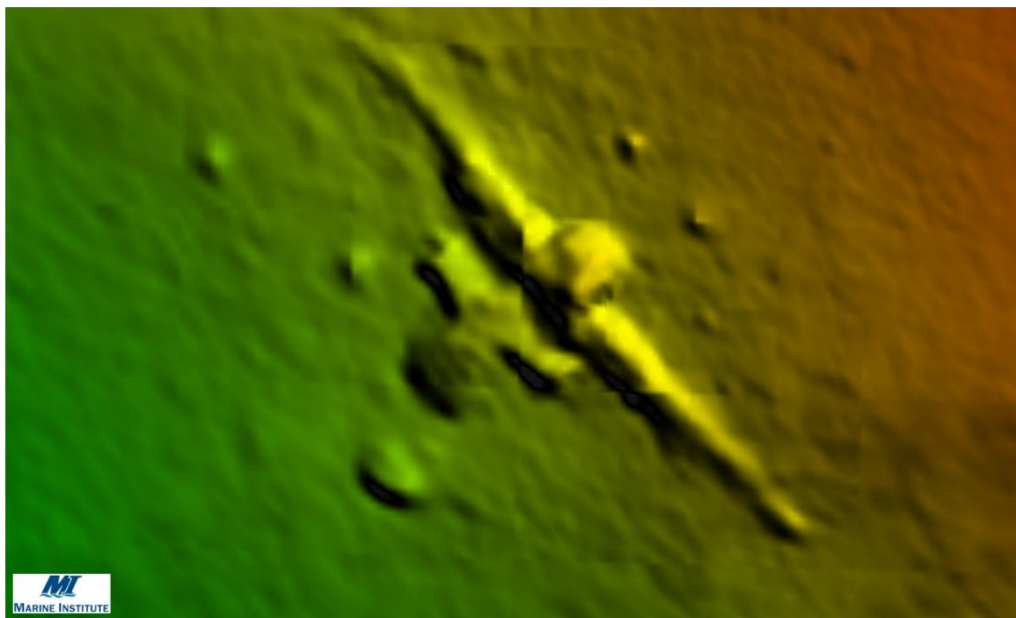
Figure 2: Multibeam echosounder image of the plane wreck site on the bottom of Gander Lake. Photo: Kirk Regular, Marine Institute.

On June 21, 2022, staff from the Centre for Applied Ocean Technology at the Marine Institute were conducting bathymetric surveys of western Gander Lake with a multibeam echosounder under contract to New Found Gold Corp. With the approval of New Found Gold, they moved their survey vessel to the eastern half of Gander Lake, to search for the wreck of Liberator 589. Using the approximate location found in the RCAF crash documents (RCAF 1943b, c), a multibeam echosounder survey (Kongsberg EM2040P operating at 400kHz) soon located the bomber wreck on the lake bottom at a depth of approximately 38 – 46 m. The exact location of the bomber wreck was determined with a Differential Global Navigation Satellite System (DGNS), positioning the wreck within 10 cm accuracy. From the multibeam sonar images, the bomber’s wings and a portion of the fuselage appeared to be fairly intact but the rest of the fuselage and tail assembly seemed to be broken apart (Figure 2). The four engines did not appear to be attached to the wing.

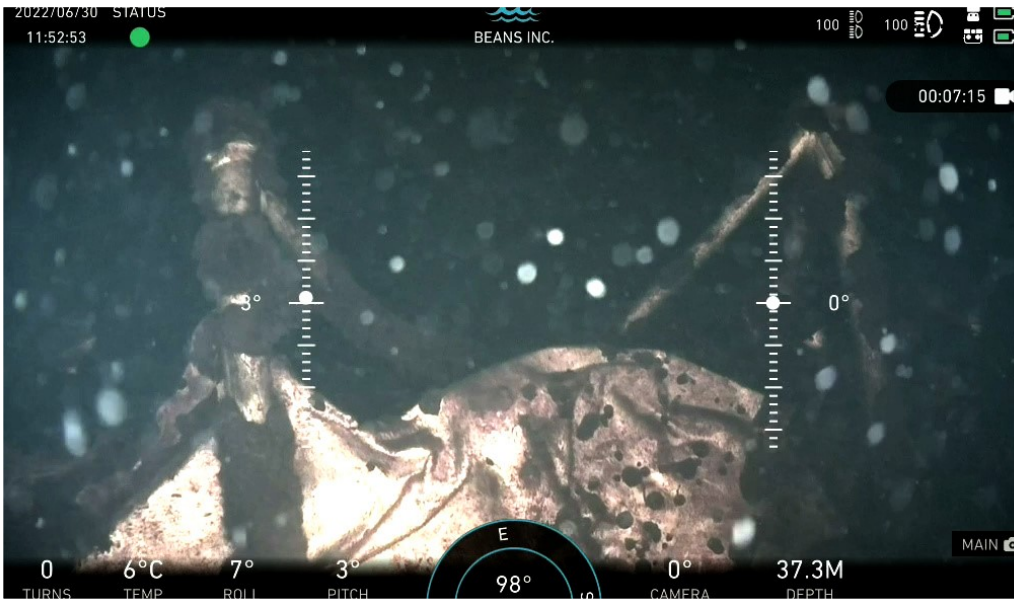
Figure 3: Frame from underwater video collected using a remotely operated vehicle (ROV) in Gander Lake. The photo shows the engine mount piping on the wing of the Liberator bomber wreck. Frame from video: Adam Templeton, Marine Institute

Video collected by the ROV showed parts of the heavily damaged fuselage and the wing with the exposed piping of an engine mount (but no engine) (Figure 3). Particulate matter stirred up by the ROV's thrusters impaired the visibility of the video images as did the brown colour of the lake water. The limited visibility resulted in the ROV images showing only small portions of the plane wreck.

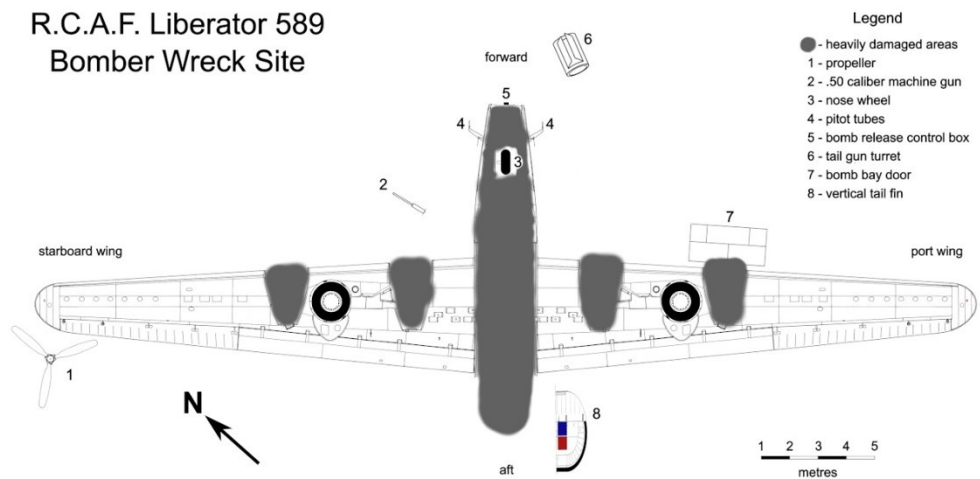
During the dives, it was apparent that the plane wreck was upside-down with the wings intact, the landing gear partially extended and the fuselage heavily damaged (Figure 4). The forward section of the fuselage was attached to the leading edge of the wing, but the bottom of this part of the fuselage was

Several parts of the plane were dislodged from the main wreck (Figure 4). A single .50 caliber machine gun and some of the ammunition feed track was partially buried in the lake bottom just forward of the inboard starboard engine mount. With the heavy damage to the nose of the plane, the contents of the bombardier's and navigator's compartment were in disarray. However, one of the bombardier's controls was sitting on top of a debris pile at the very nose of the plane wreck. This was the bomb release interval control box (or intervalometer), which controlled the number of bombs dropped and their spacing (Figure 7) (Consolidated Aircraft 1942). Near the nose of the plane wreck, the tail machine gun turret was displaced from the fuselage and found lying on its front on the lake bed (Figure 8). One of the bomb bay doors was lying flat on the lake bottom just forward of the outboard port engine mount. One of the vertical tail fins was partially imbedded in the bottom just behind the inboard port wing. A RCAF fin flash (red and blue

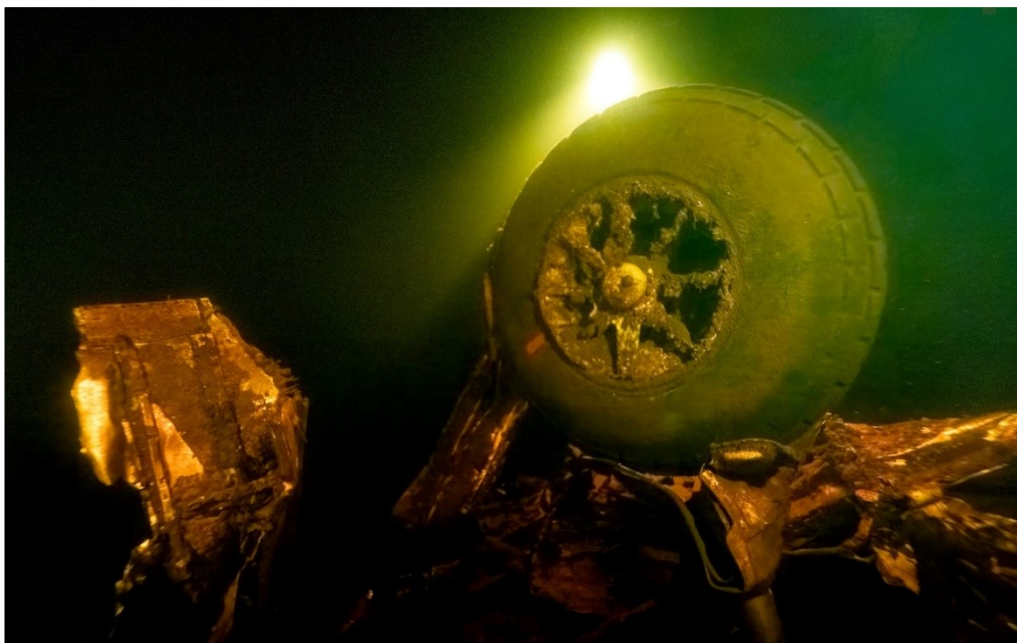
Figure 5: Nose wheel of landing gear in the extended position. Metal pieces on the left are the two nose wheel doors that close when the wheel is retracted into the fuselage after take-off. Frame from video: Jill Heinerth

lake bottom and were not visible. The nose wheel of the landing gear was extended (Figure 5) but the two larger wheels on the underside of the wings were almost fully retracted.

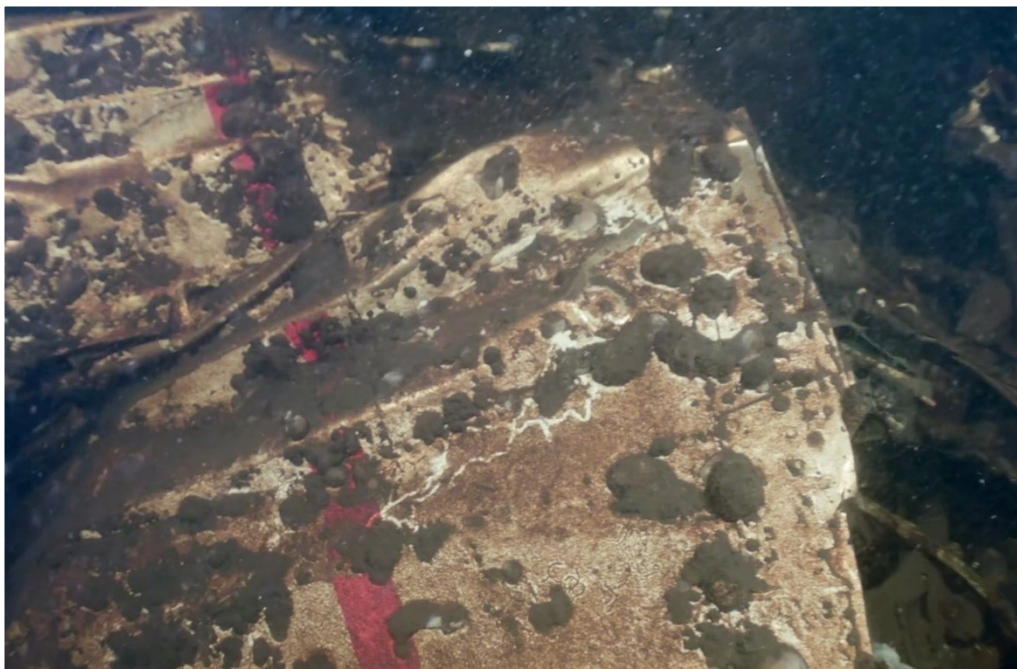
Several markings on the exterior of the forward fuselage and underside of the wing were visible. A vertical red propeller warning stripe (about 5 cm wide) was seen on either side of the forward fuselage. Similar horizontal red stripes were located outboard of the outboard engine mounts on the underside of each wing. These stripes can be seen in Figures 1 & 6.

Figure 6: Vertical red propeller warning stripes on the port side of the forward fuselage. Frame from video: Maxwell Hohn

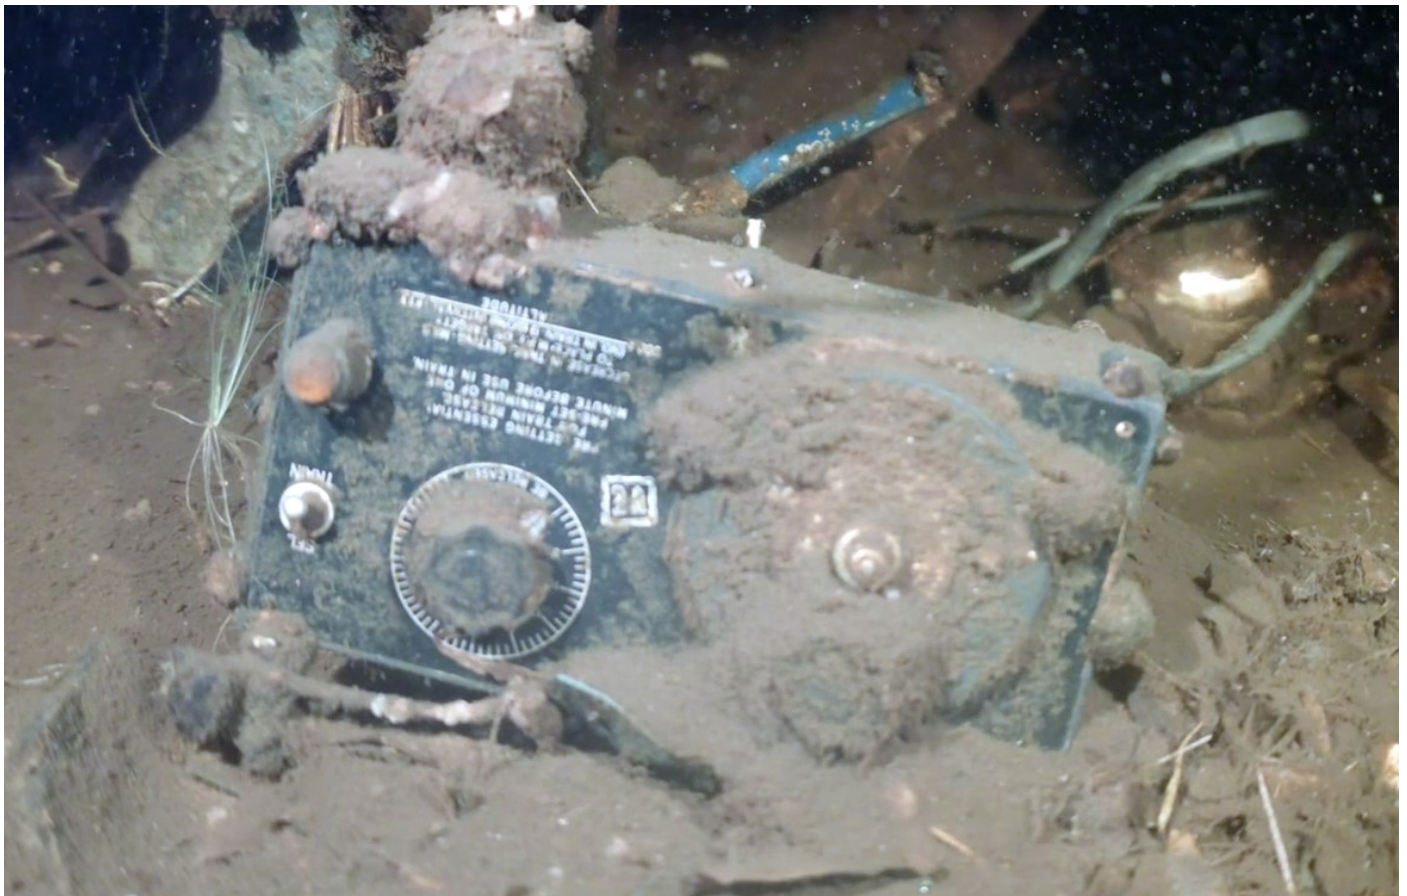
Figure 7: Bomb release interval control box in the open nose of the bomber wreck. Frame from video: Maxwel Hohn

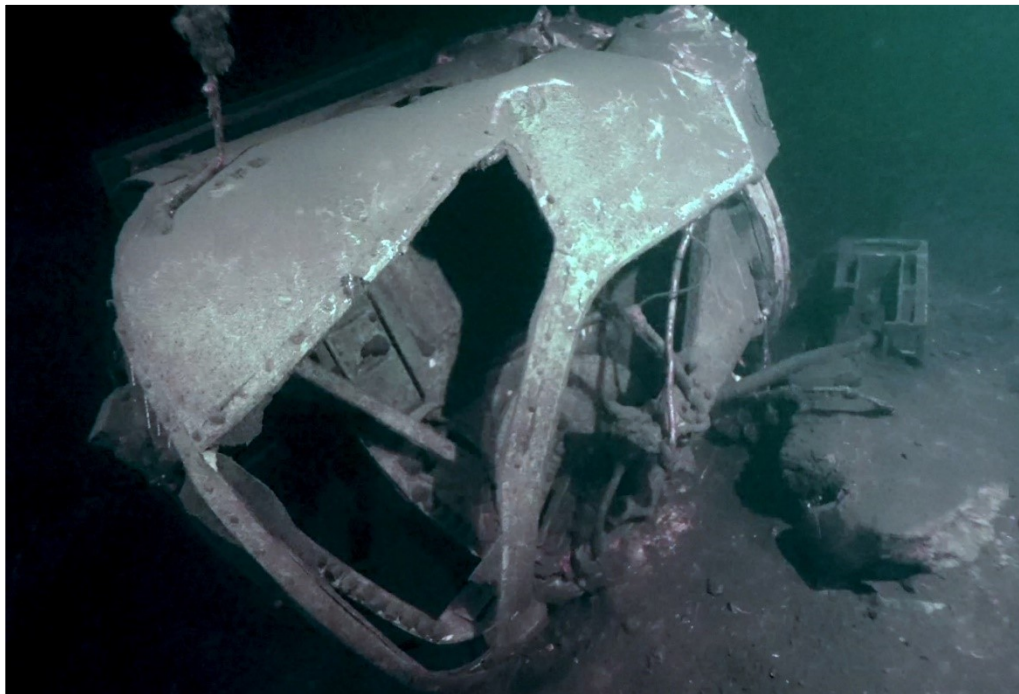
Figure 8: Tail machine gun turret lying on the lake bed near the nose of the bomber wreck.
 Frame from video: Jill Heinerth

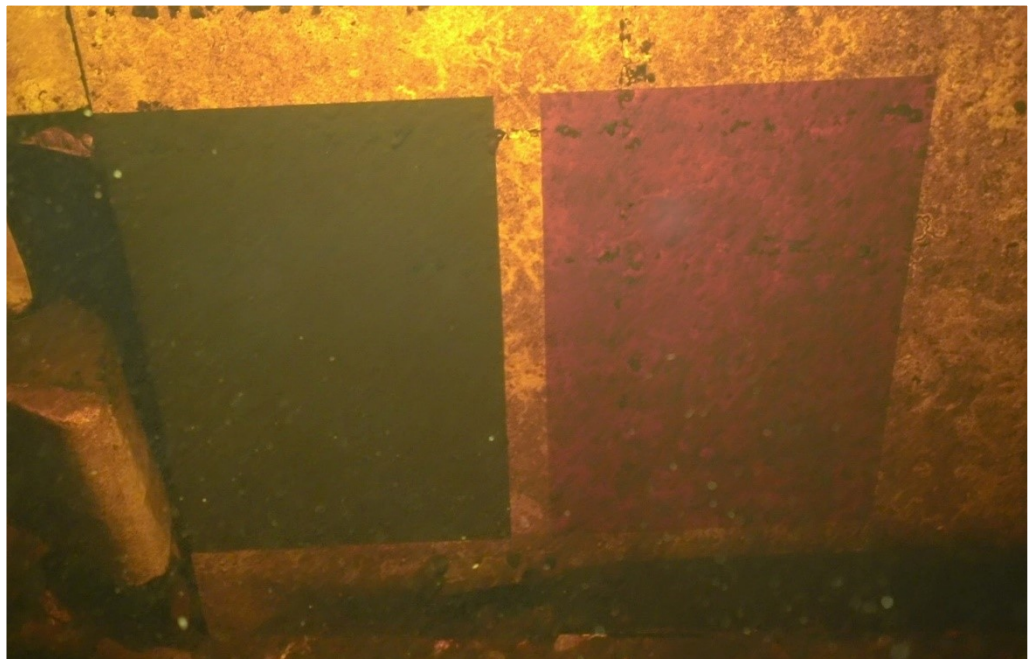
flag) was clearly marked on the side of this tail fin (see Figures 1 & 9). What looked like a second bomb bay door lay crumpled beside the tail fin.

Figure 9: RCAF fin flash on vertical tail fin of Liberator bomber wreck.
 Frame from video: Neil Burgess

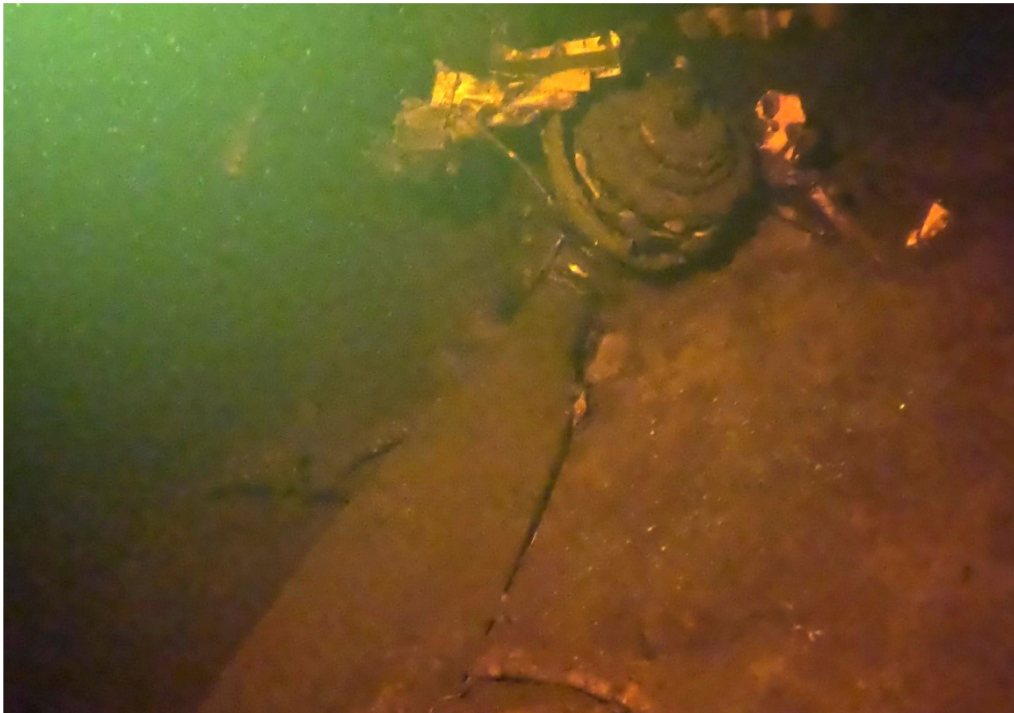
On October 16 & 17 2022, additional diving surveys were carried out to collect more video of the bomber wreck. These surveys focused more on the starboard wing and fuselage. One three-bladed propeller assembly was found near the starboard wingtip (Figure 10). Two of the propeller blades were bent. There were masses of bent tubing and wiring still attached to the starboard engine mounts, but not on the port side. An engine oil cooler and oil tank were also found connected to the inboard starboard engine mount only.

**Figure 10: Propeller with three blades near the starboard wingtip.
Frame from video: Rick Stanley**
